Manhole Inspection Summary

Manhole # S21AA_029MH

Location Address: **1926 MOSHER-ALLEY-LAFEYETTE** Cross Street: **APPLETON ST**

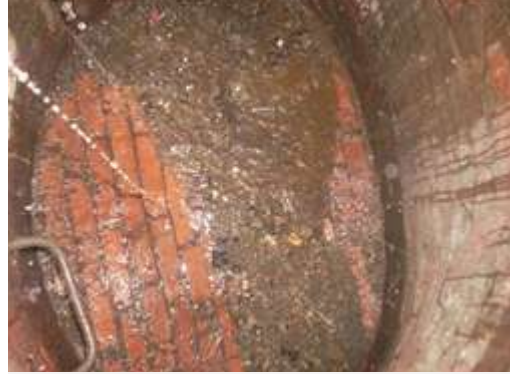
Top View

DEBRIS IN CHANNEL

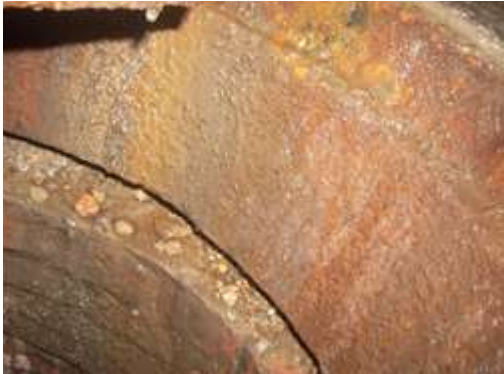
Defect 2

Corbel Material: **Brick** ☐ Parged Type: **Concentric/Eccentric**
Condition: ☐ Sound ☐ Cracked ☐ Root Intrusion ☐ Loose Brick ☒ **Deteriorated**
Infiltration: ☒ None ☐ Joint ☐ Cracks ☐ Mortar ☐ Roots ☐ Wall

DETERIORATED CORBEL

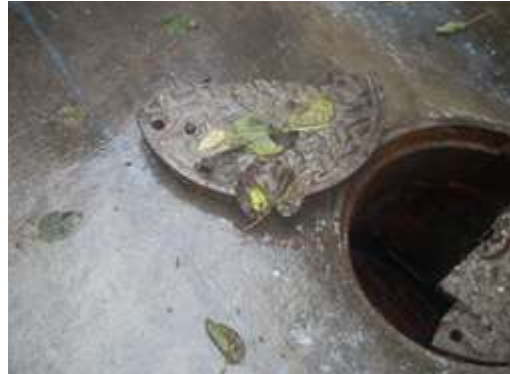
Defect 1

Cover Shape: **Circular** Diameter: **24** (in.) Length: (in.) Dist A/B Grade: **0** (in.)
Type: **Sanitary** Condition: **Broken** Cover Material: **Cast Iron**
Properties: ☐ Bolted ☐ Vented ☐ Water Tight ☐ Water Tight Insert

BROKEN LID

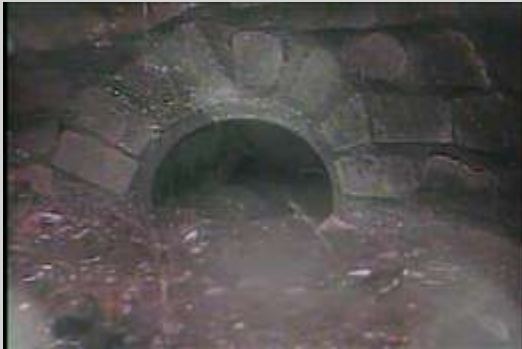
12 O'Clock Outflow

8 in. Circular Gravity Sewer
Pipe Out @ 12 O'Clock

Deposits: ☐ None ☐ Mud ☐ Sludge ☒ **Debris** ☐ Grease

Silt Depth: **1** (in.) Deposits Extent: **Light**
